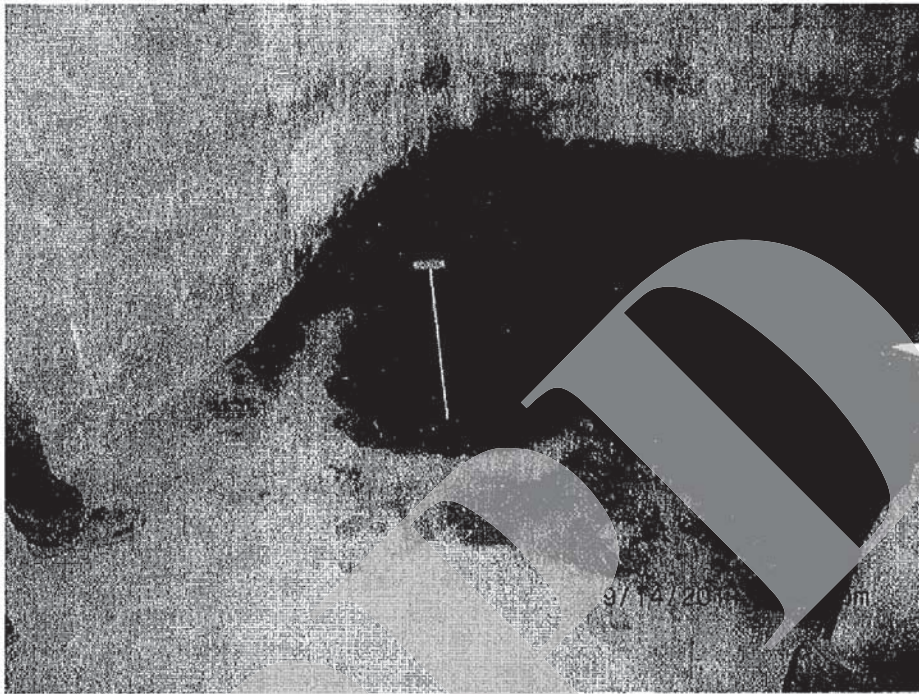
Photo 47 – Piping feature/sand boil (about 1 foot deep, 3.5 feet in diameter) in the Missile Shield Room on the south side of the Auxiliary Building.

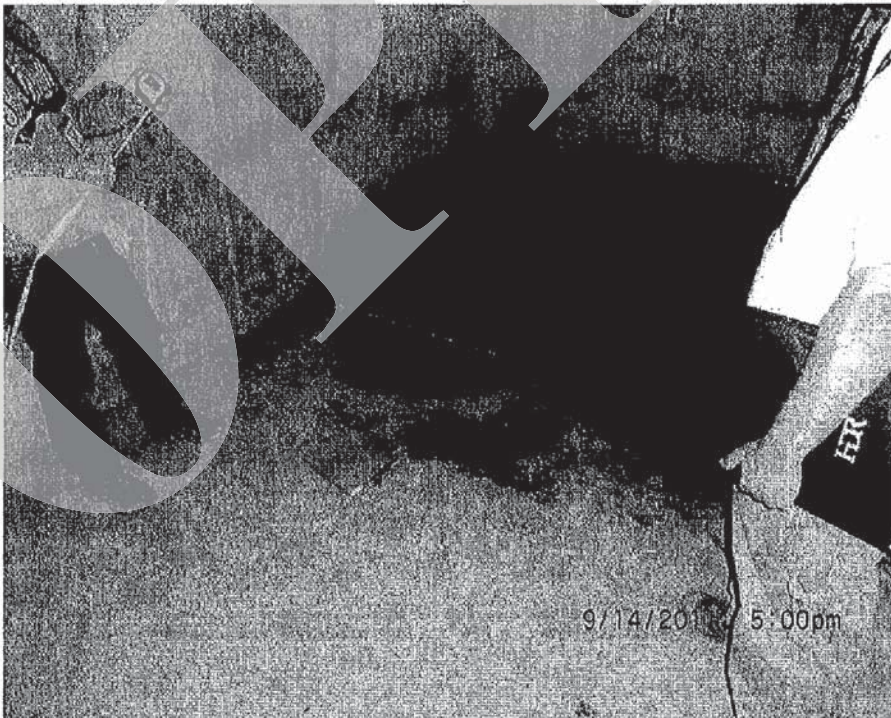
Photo 50 - Piping feature/sand boil (about 1 foot deep, 3.5 feet in diameter) in the Missile Shield Room on the south side of the Auxiliary Building.

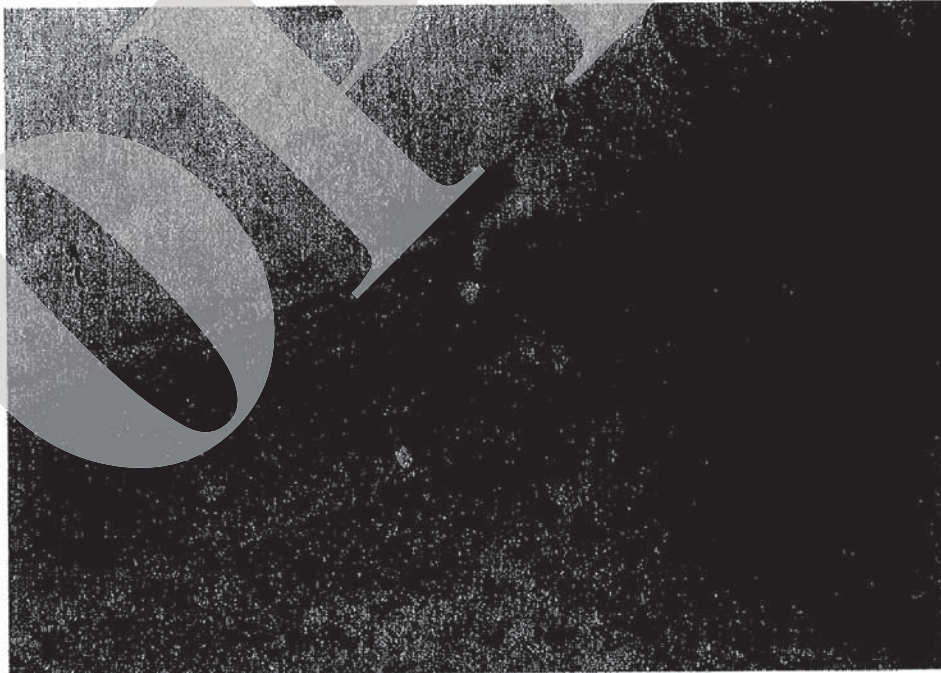
Photo 52 – Thin (about 1/16-inch thick) layer of sediment apparently piped into the room.
