# FUKUSHIMA

## ANNUAL REPORT

14th Anniversary  
Report

MARCH 2025

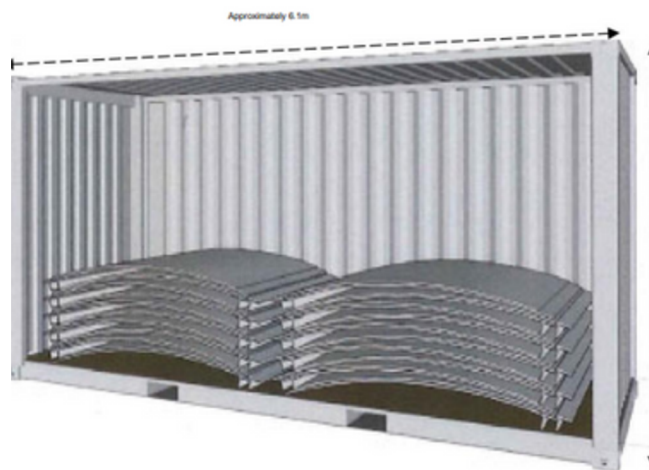
<Image of storage in a 20-foot full-height container>

The J8 and J9 tank farms at Fukushima Daiichi are being disassembled. These newer welded tanks are being cut apart and the pieces loaded into storage boxes. The storage boxes will be located in a temporary storage area north of units 5 and 6.

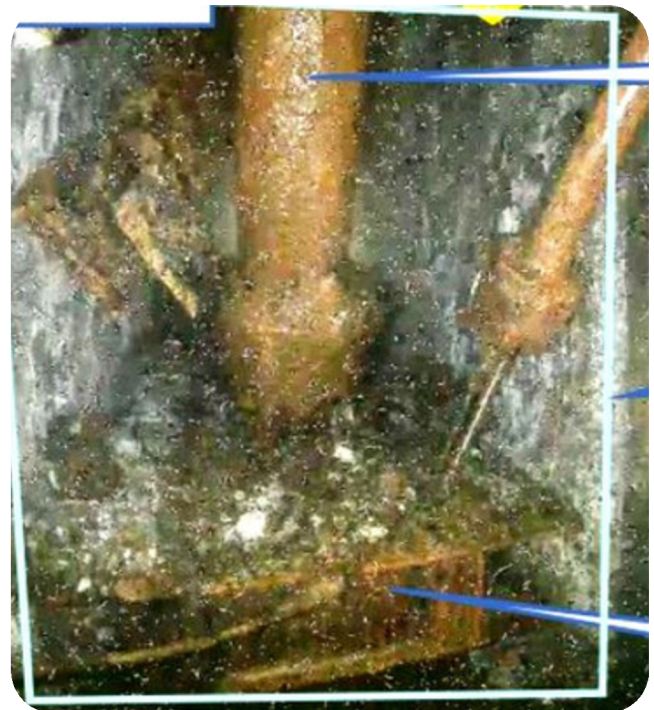
Among the findings were control rod drive units that operate the introduction and withdrawal of control rods into the reactor vessel. At least one of these pieces of equipment was found warped and hanging upside down.

A cluster of TIPS probes were found heavily damaged and melted where they would have routed into the reactor vessel above.

*Enhanced images from inside unit 1 include the underside of control rod drives, the control rod drive opening in the upper pedestal and a lumpy object, likely fuel debris. Images clockwise*

In late March of 2024 TEPCO used a snake robot and a drone to capture some imagery of the interior of the upper section of the pedestal. This area is closer to the bottom of the reactor than previous surveys that were at the base of the pedestal.

This damage indicates a significant failure of the bottom head of the reactor, something that could be assumed by the fuel debris and damage found at the bottom of the pedestal but further confirmed by these findings.

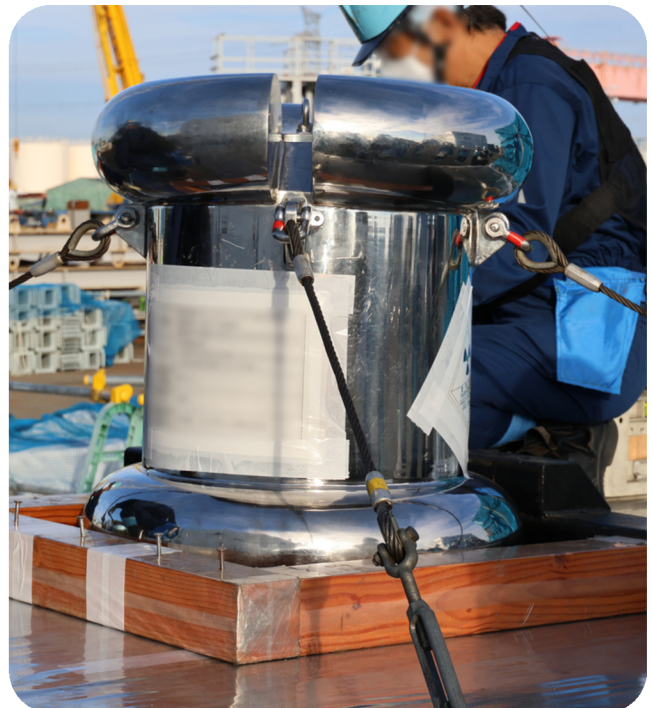
*Fuel debris transport container. Image Credit TEPCO*

Once the sample was loaded into the specialized transport container and strapped to a flatbed truck it was taken to the JAEA Oarai lab. This work was considered completed by October of 2024.

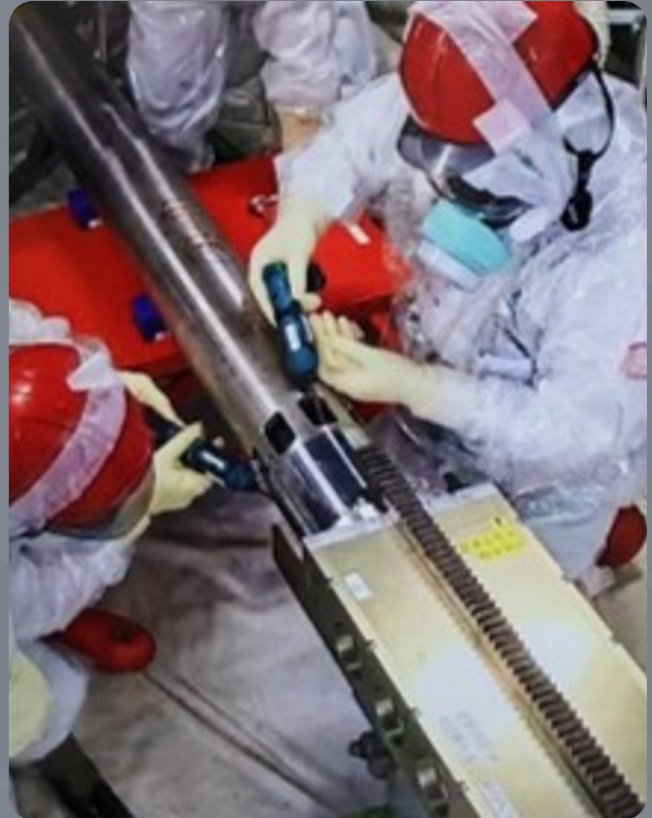
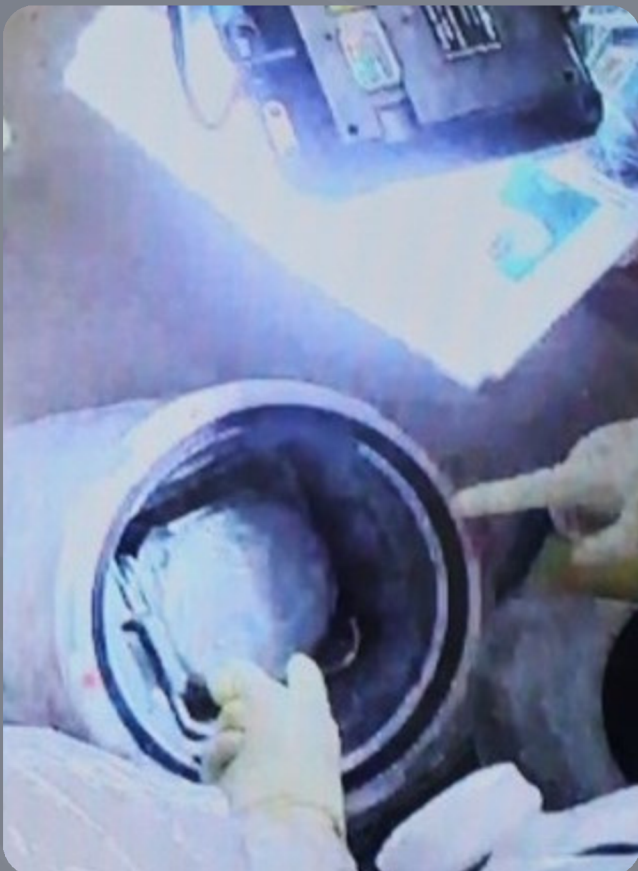
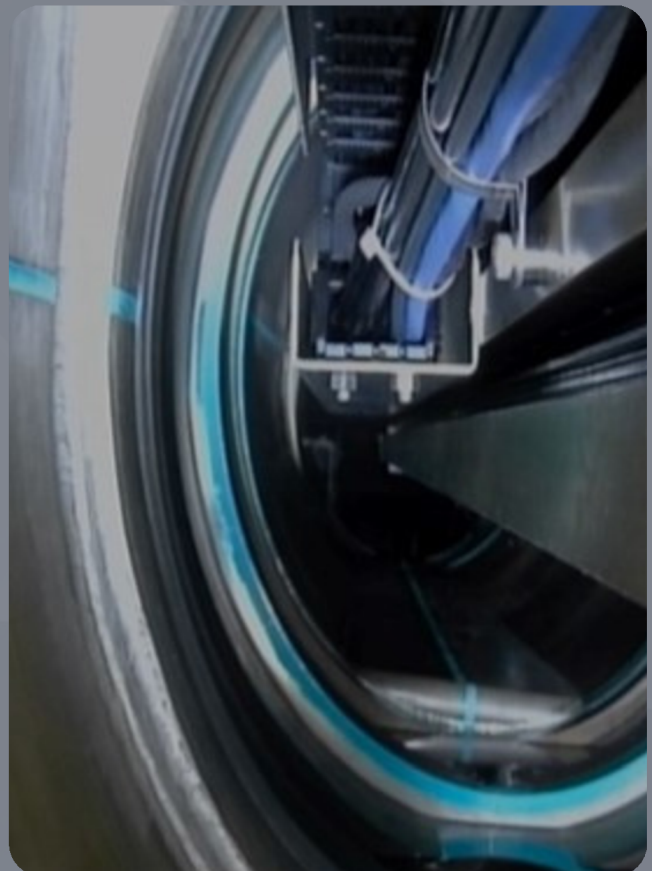
Images from the fuel debris sample removal work at unit 2. (clockwise)

Workers operating the fuel removal rig at the X6 containment opening.

The X6 containment opening while the fuel removal rig was in use

Packing the obtained fuel debris sample in the inner transport container before placement in the transport container

Once the sample was retrieved from containment, it was moved to a glove box unit stationed inside unit 2. Some initial data and readings were gathered before moving the sample into a shielded transport box.

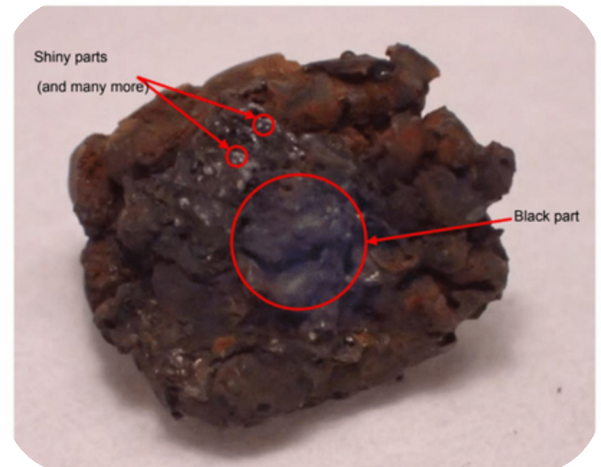
Images top to bottom:

Retrieval of fuel sample from unit 2 pedestal

Fuel sample before breaking

Fuel sample after chipping a piece off with a metal rod

JAEA released a report on their analysis of the fuel debris sample. They found it to be uneven with voids widely distributed inside and the presence of fuel materials like uranium among other things found in the sample. The sample was collected from the edge of the debris pile inside unit 2's pedestal. This may provide clues to the meltdown progression during the disaster.

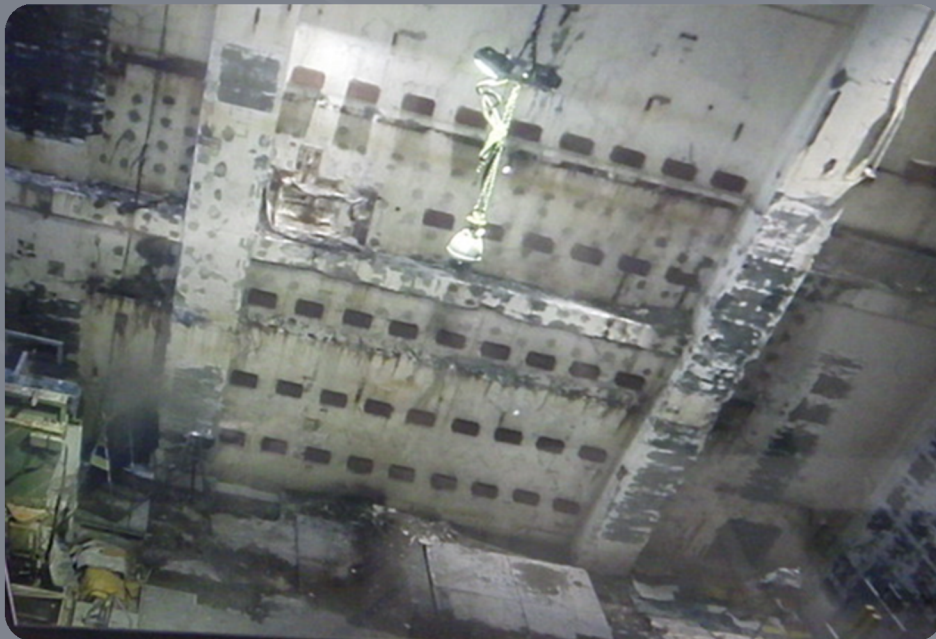
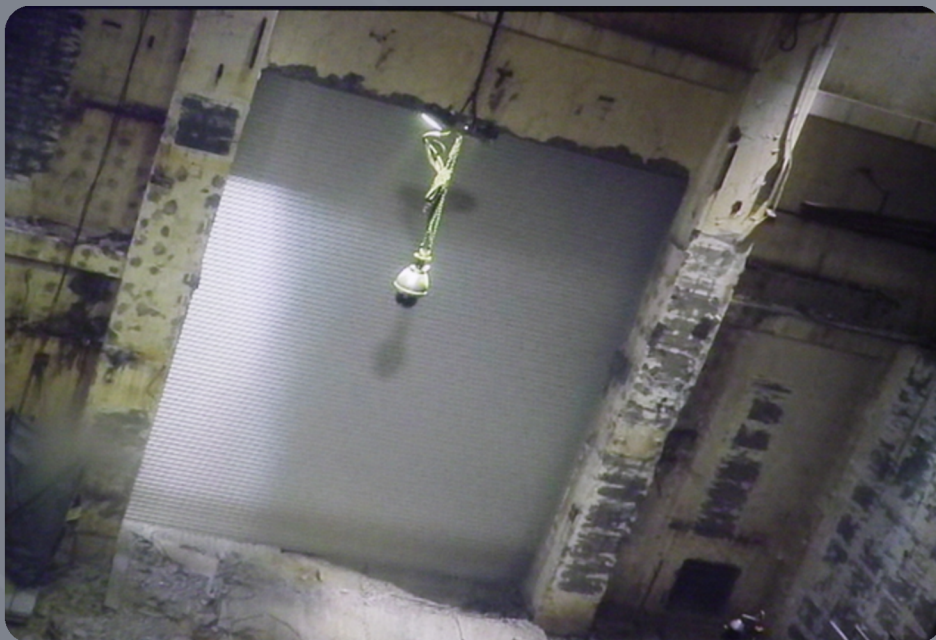
*Images above, unit 2 refueling floor exterior wall before and after cutting to install an overhead door.*

A pipe for the spent fuel pool heat exchanger was found to be leaking in October. TEPCO said it planned to repair the pipe, no further communication about its repair was found. In November 2024, work was underway to cut a doorway in the concrete wall of the refueling floor level to aid access for removing spent fuel. The final work included a steel overhead door to close the opening.

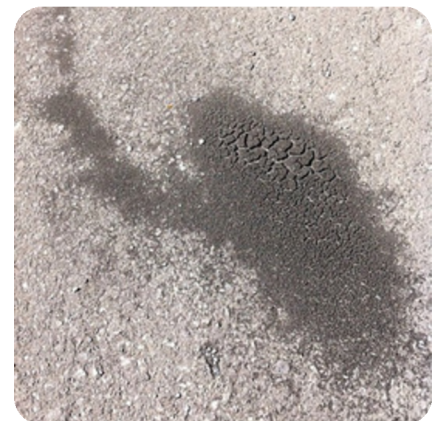
*Image right: black deposit of cesium bearing microparticles on pavement in Tokyo, identified April 2012*

While some environmental levels go down, microparticles of radioactive contamination remain a significant threat. These are high in radiation, insoluble so they are difficult to expel out of the body, and small enough to inhale. The Bulletin of Atomic Scientists published an in-depth article of the scientific findings around cesium bearing microparticles that fell on Tokyo on March 14th and 15th in 2011 after unit 3 exploded.

The additional analysis of the air filter samples collected confirmed that small micron insoluble highly radioactive microparticles fell on Tokyo. The article dives into the years-long battle between researchers, institutions, and government entities in Japan to try to prevent the research findings from being made public.
