# FUKUSHIMA

## 15th Anniversary

*SimplyInfo.org Annual Report On The Fukushima Nuclear Disaster*

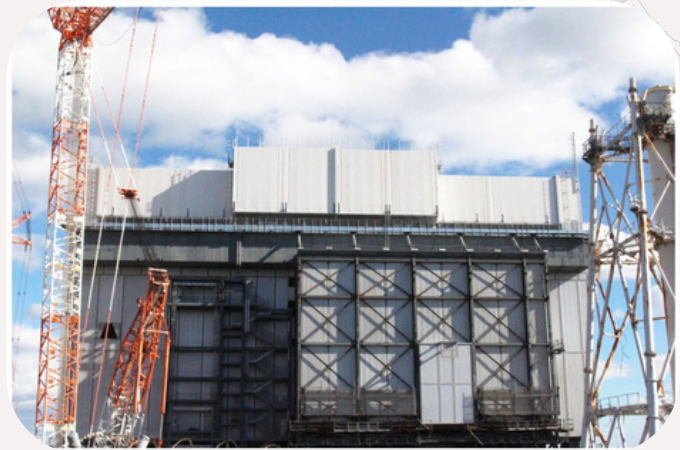
On January 19, 2026, Tokyo Electric Power Holdings announced the completion of a large protective cover over the Unit 1 reactor building at Fukushima Daiichi, with the final movable roof adjustment finishing that day. The cover is designed to control dust scattering and rainwater inflow as workers prepare for fuel extraction from the spent fuel pool, which is slated to begin in FY2027–2028.

This new work follows years of concern over the radioactive debris on the refueling floor of Unit 1. The recent photos from the refueling floor show significant radiation-induced pixelation, showing that even 15 years later, this area is extremely unsafe.

This is the third cover to be placed over Unit 1. The first was hastily installed in October of 2011 without explanation. Years later, we know the concern was the high levels of radioactive fuel dust and small fuel debris.

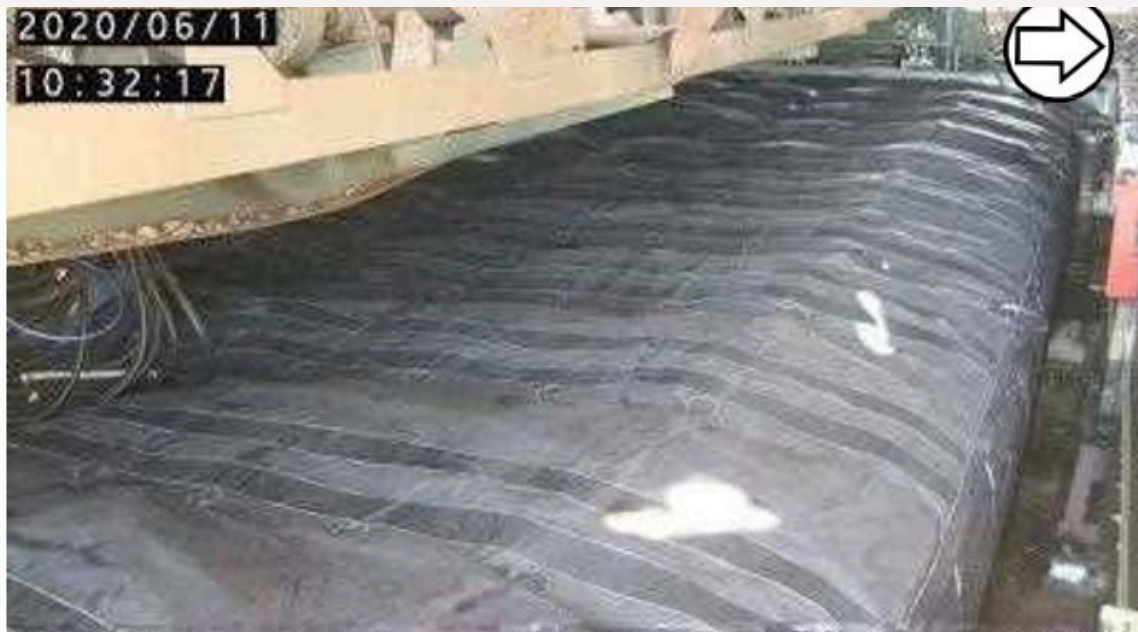
Air mortar filling (Photo date:  
2020.6.11)

Unit 1 spent fuel pool “curing” pool protection

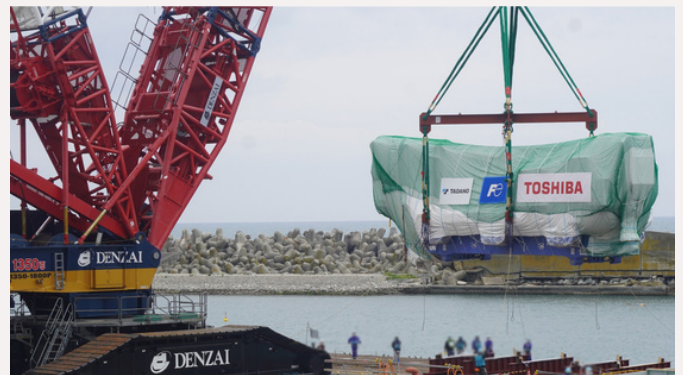
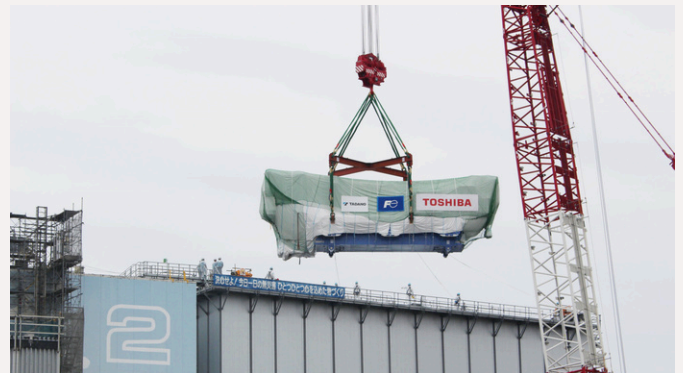
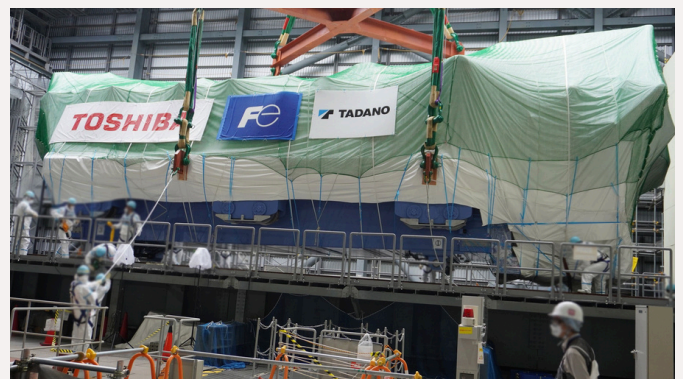
The second report, dated May 30, 2025, confirmed that the fuel handling machine was successfully hoisted by crane onto the top of the Unit 2 fuel removal work platform and affixed to the runway girder rails, the structural foundation of moving rails spanning the reactor building, and the platform. This represented a significant step forward in the broader decommissioning effort at Fukushima Daiichi. TEPCO plans to start actual fuel removal from the Unit 2 SFP during fiscal year 2026.

In May 2025 TEPCO announced that the equipment was shipped from the manufacturer's factory on May 21 and successfully delivered to the power station site on May 24 via supercarrier. At the time of that announcement, preparations were underway to transport the equipment to the front room of the fuel extraction platform. The equipment provided by Toshiba consists of five major components: a crane, a fuel handling machine, a vertical spreader (also referred to as a vertical hoist), a transport container simulator, and a traveling trolley.

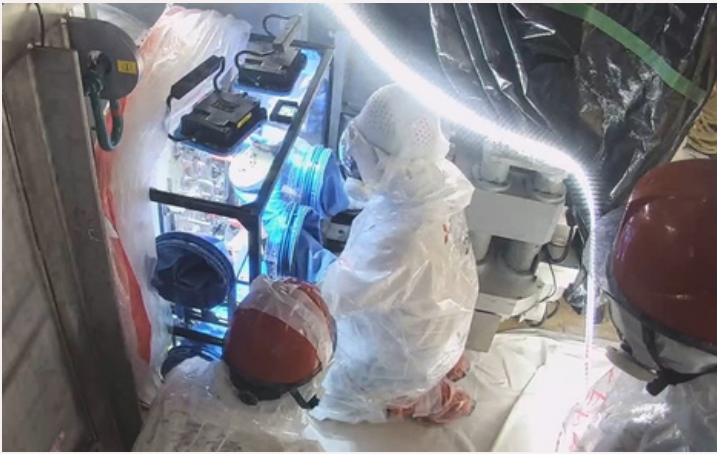
The fuel debris sample is brought into a hot cell connected to the rig for the retrieval arm. Initial readings are taken before removing it to the small transit container.

Removed fuel debris sample in the shielded inner container, preparing it for transport.

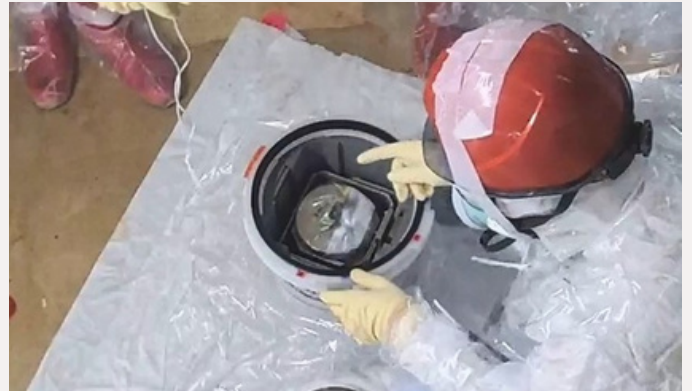
Fuel debris sample placed in transit container that is then strapped to a mobile sled before being mounted in the flat bed truck. The truck delivered the sample to the hot lab at Oarai in Ibaraki prefecture.

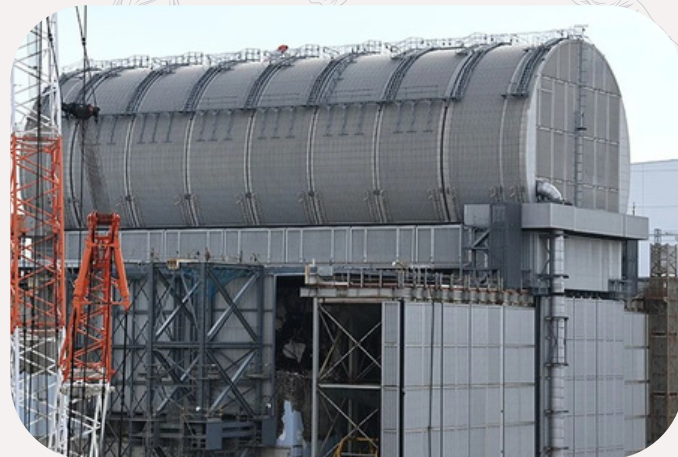
TEPCO conducted a survey as part of preparation work for fuel debris removal at Unit 3. Engineers are planning to access and remove fuel debris through the X-6 and X-1B penetrations. To evaluate whether additional penetrations (specifically X-2) might also be usable, they needed a clearer picture of conditions inside the Personal Airlock (P/A) room, which serves as a passage for workers entering the containment vessel.

Before committing to construction methods and worker access plans, they needed to verify the radiation environment on the first floor of the reactor building. The last survey was in 2016 and showed very high radiation doses, so they needed current data to inform safety planning. Because those 2016 readings were so elevated, they used remote-controlled robots rather than sending workers in directly. Radiation levels (air dose equivalent rates) had fallen significantly across all five measurement points compared to 2016:

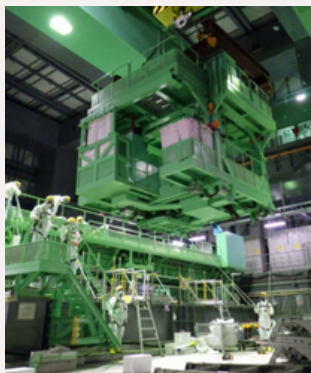
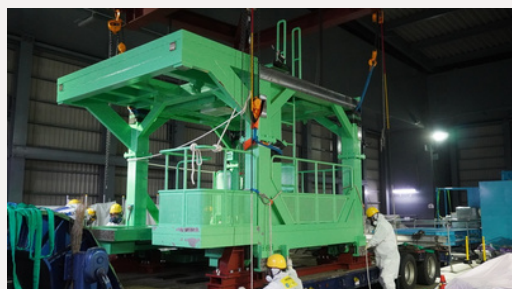
In November of 2025, TEPCO removed the fuel handling machine from above the unit 4 spent fuel pool. The defueling building and the fuel handling crane had been installed as a suspended system over the heavily damaged unit 4. Concerns for both the stability of the outer building and the spent fuel pool itself caused the decommissioning efforts to address unit 4's spent fuel first. With the pool fully emptied of fuel and contaminated reactor components such as control rods, the fuel handling machine was no longer needed.

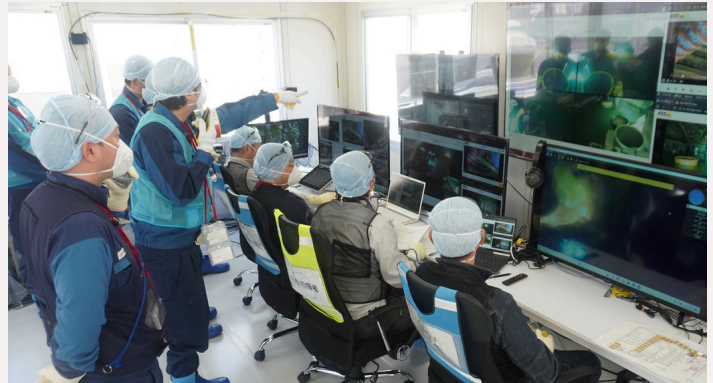
TEPCO began collecting radioactive zeolite and activated carbon sandbags from the basements of the High Temperature Incinerator Building (HTI) and Process Main Building (PMB) at Fukushima Daiichi on March 26, 2025. These bags were originally placed after the accident to adsorb radioactive materials from stagnant water, but have since deteriorated and can no longer be moved intact. Using remotely operated vehicles (ROVs) in the high-dose, darkened basement environment, workers are vacuuming out the zeolite contents and consolidating them — a process that will take roughly a year. The collected material will then be dewatered, sealed into metal storage containers, and transported to a temporary storage facility, with the full encapsulation work expected to be completed by FY2026–2027.

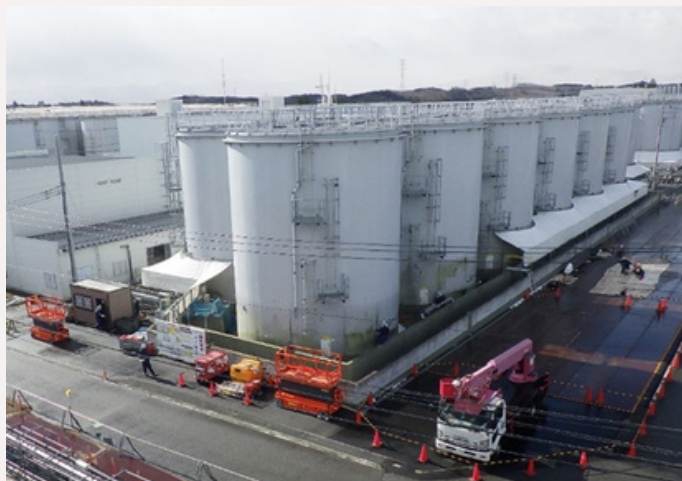
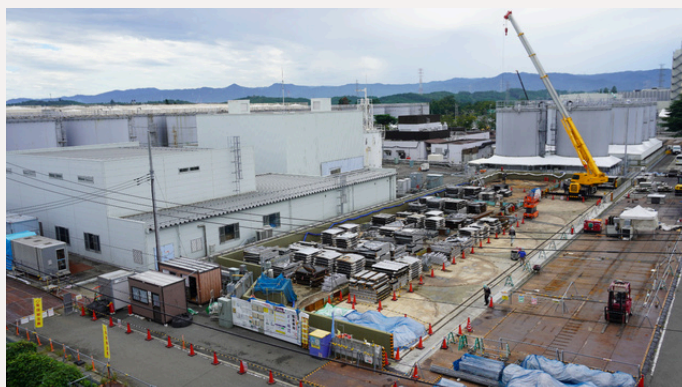
TEPCO reported on the dismantling of contaminated water storage tanks in the J8 and J9 water tank areas. Work at J9 came first, with the dismantling of 12 welded tanks (each 700 m<sup>3</sup> capacity) beginning on February 14, 2025, with completion on September 3, 2025. The tanks had stored ALPS-treated water that was discharged into the ocean before dismantling.

The J8 area, containing 9 similar tanks, followed next — its stored water was transferred between July and November 2025, with preparatory work continuing through late 2025, and full dismantling beginning January 20, 2026, with completion targeted for the end of FY2026.
